**PROJECT MANUAL**

**CMHA ASPIRE COLUMBUS**

**DEMOLITION PACKAGE**

**NOVEMBER 12, 2024**

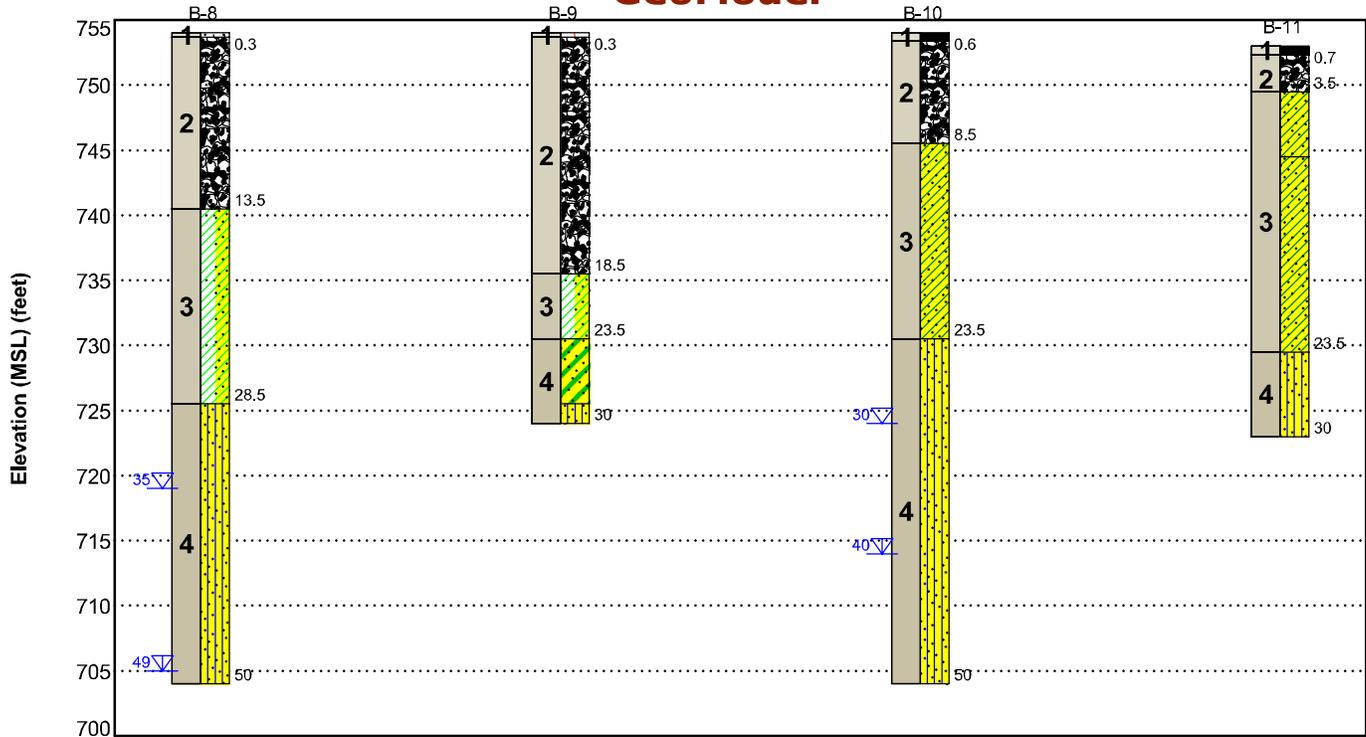
## GeoModel

This is not a cross section. This is intended to display the Geotechnical Model only. See individual logs for more detailed conditions.

Model Layer	Layer Name	General Description
1	Surface	Asphalt - 4 to 9 inches Aggregate Base - 3 to 11 inches Topsoil - 3 inches
2	Existing Fill	Sandy lean clay, lean clay, poorly graded sand, silty sand
3	Native Clay	Sandy lean clay, lean clay - very stiff to hard
4	Native Sand	Silty sand, poorly graded sand, sandy silt, clayey sand - medium dense to very dense

We have developed a general characterization of the subsurface conditions based upon our review of the subsurface exploration, laboratory data, geologic setting and our understanding of the project. This characterization, termed GeoModel, forms the basis of our geotechnical calculations and evaluation of the site. Conditions observed at each exploration point are indicated on the individual logs. The individual logs can be found in the [Exploration Results](#) and the GeoModel can be found in the [Figures](#) attachment of this report.

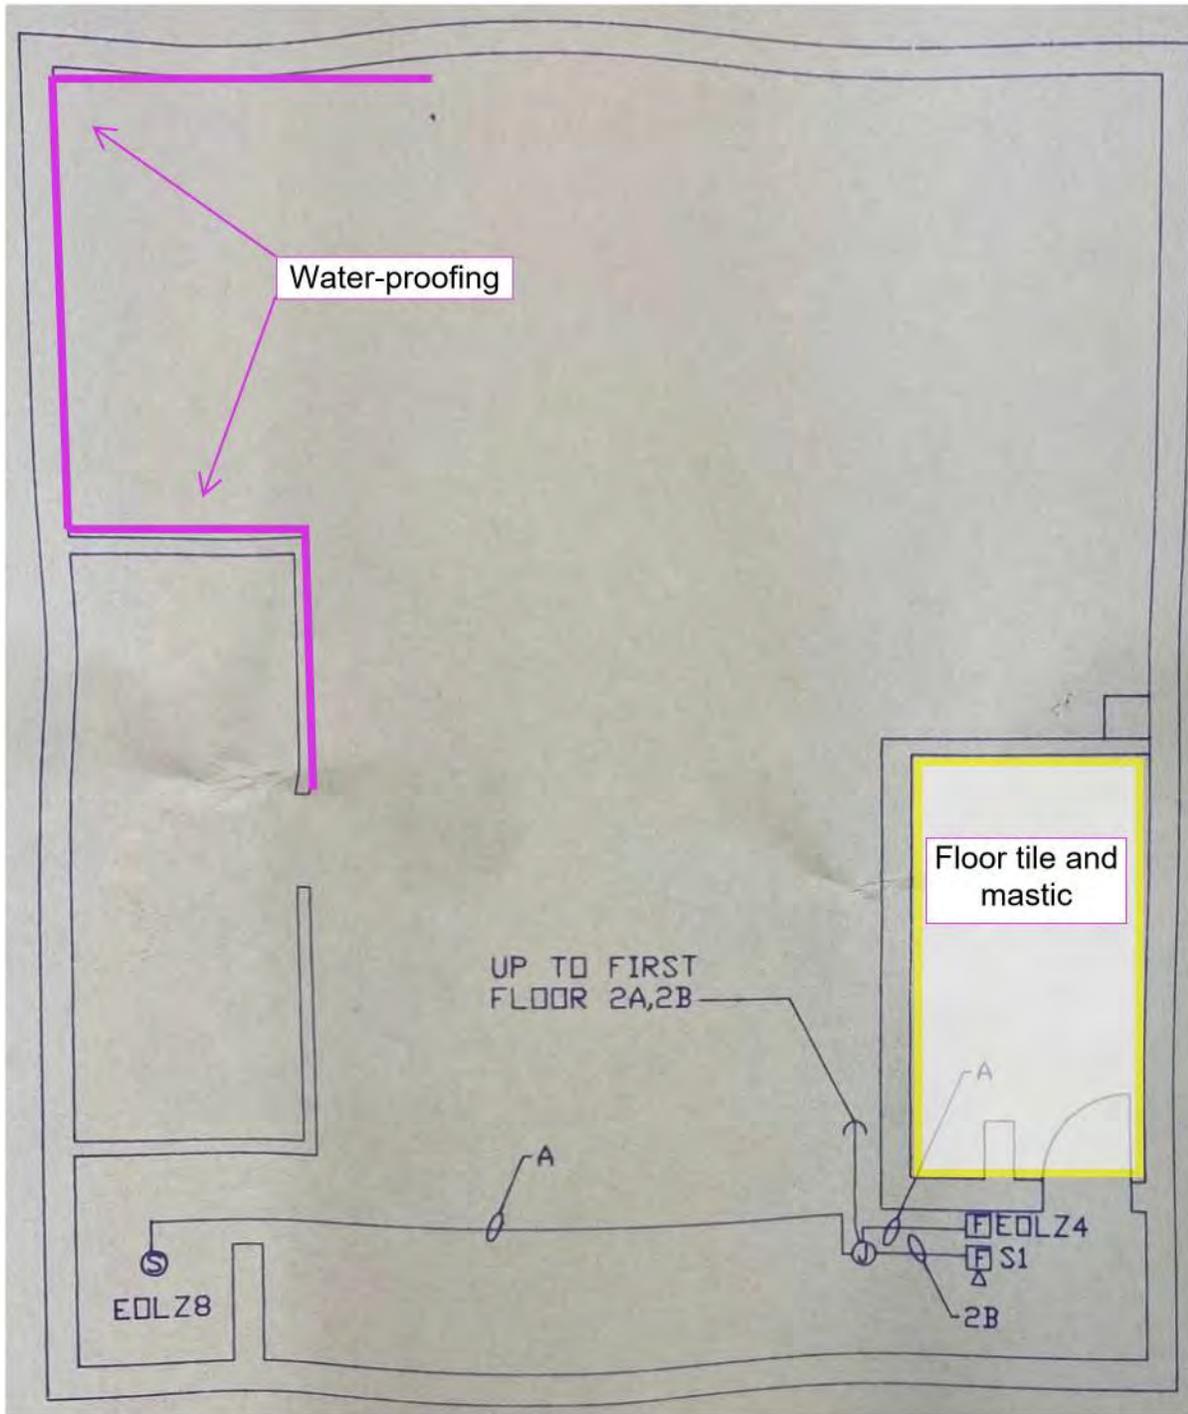
# BASEMENT

12460 Plaza Drive Cleveland, Ohio 44130	ASBESTOS LOCATION DRAWING	Exhibit
Drawn by: KB	Scale: NO SCALE		The United Way of Central Ohio 360 South 3rd Street Columbus, Ohio	1
Checked by: JT	File Name: Exhibit 1			
Approved by: JT	Date: 01/24/23

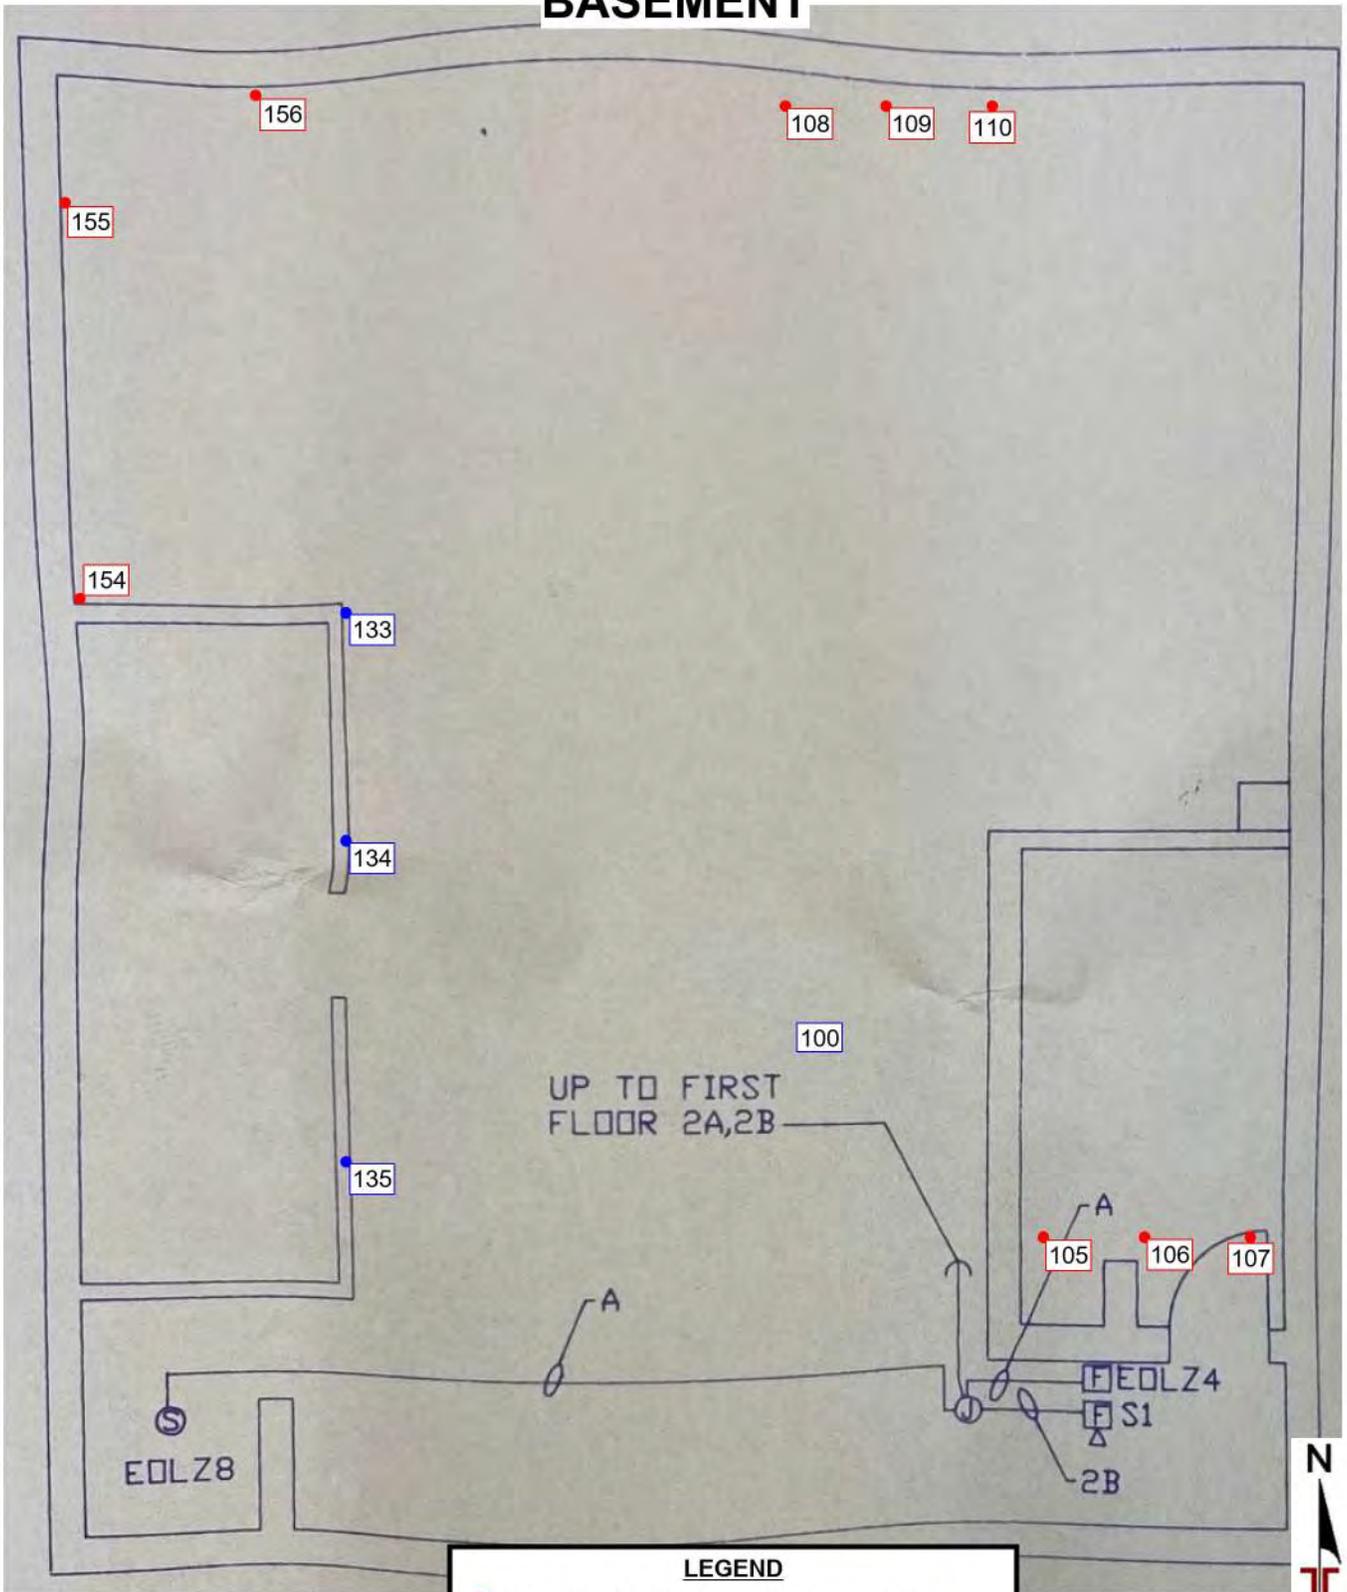
# BASEMENT

- Samples identified as asbestos-containing
- Samples identified as non-asbestos-containing

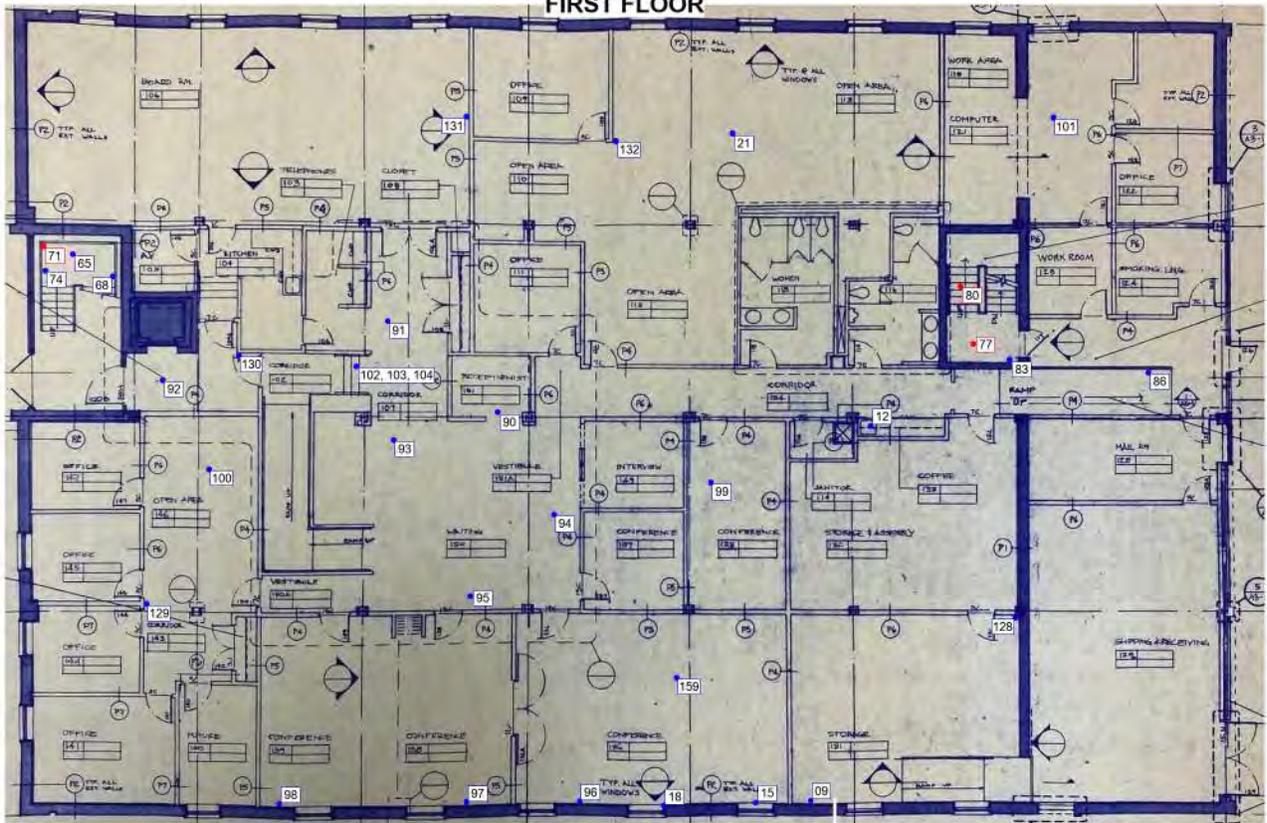
**FIRST FLOOR**

- Samples identified as asbestos-containing
- Samples identified as non-asbestos-containing

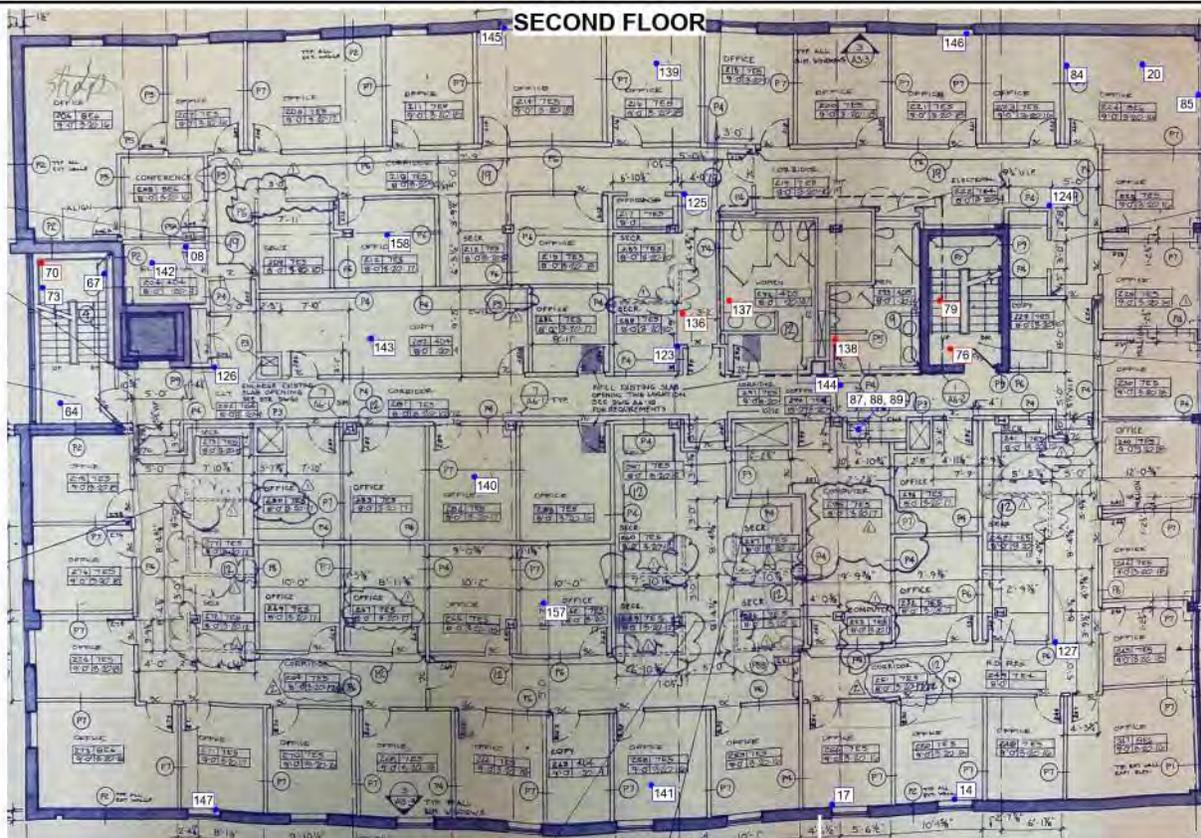
2

LEGEND	
●	Samples identified as asbestos-containing
●	Samples identified as non-asbestos-containing

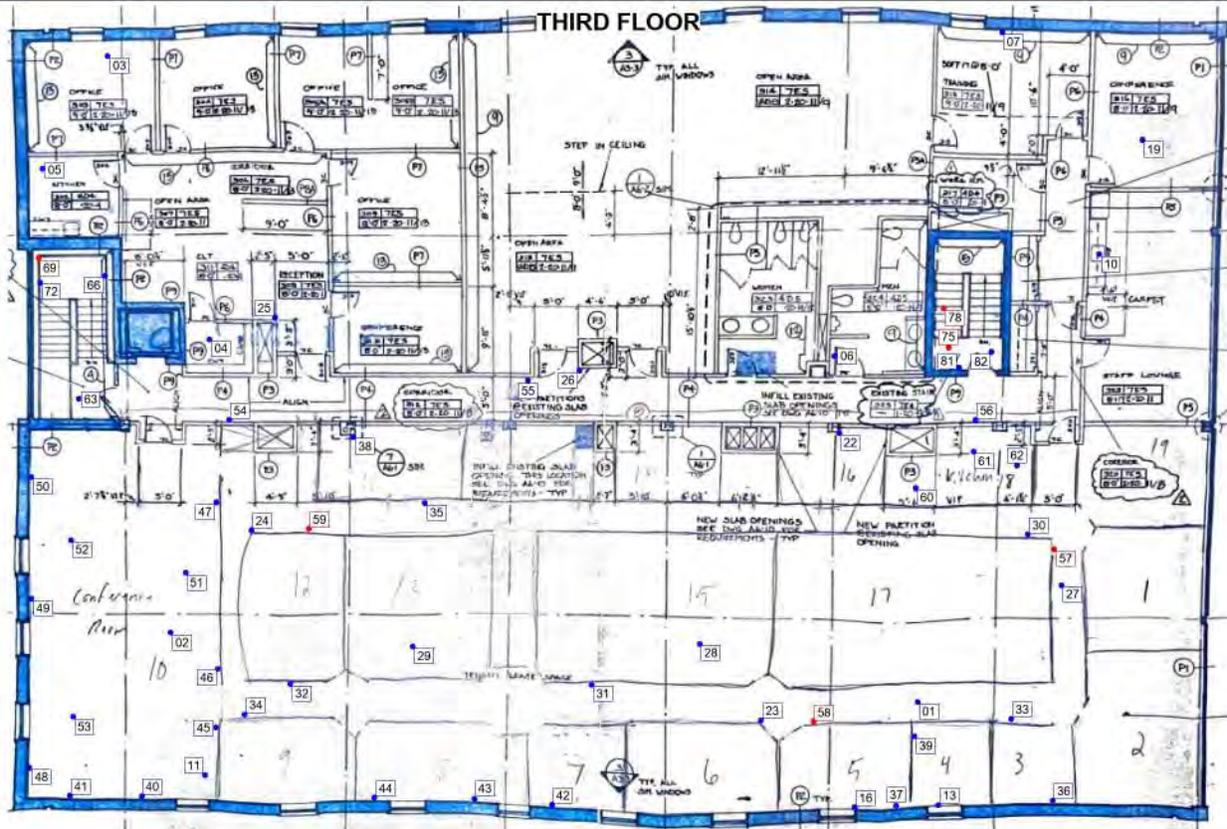
Exhibit
3

**LEGEND**  
 ● Samples identified as asbestos-containing  
 ● Samples identified as non-asbestos-containing
